Experiments in the Reconstruction of Roman Wood-Fired Glassworking Furnaces: Waste Products and Their Formation Processes

Based on experiments conducted by Mark Taylor and David Hill

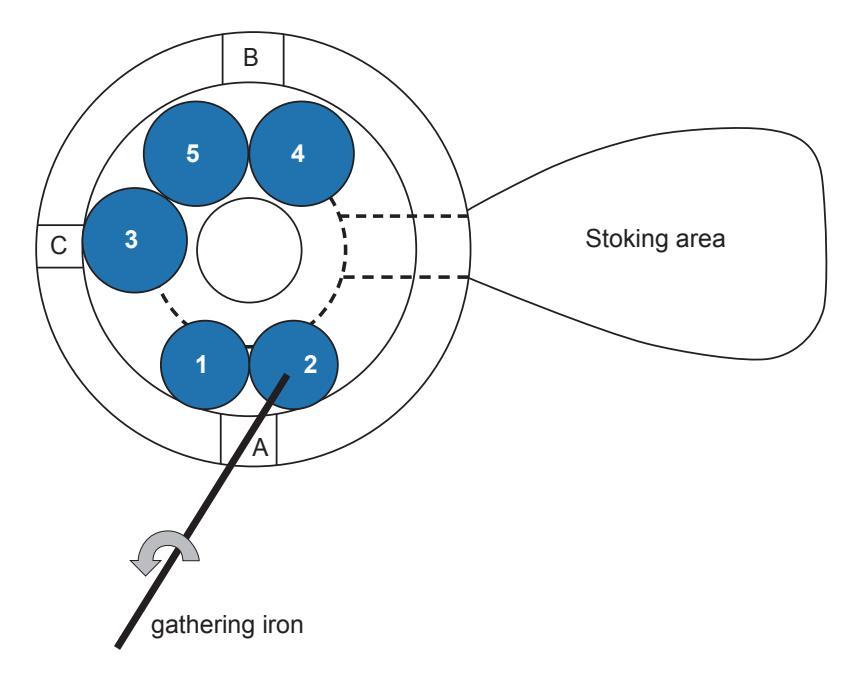
FIG. 1. Plan of pot furnace, showing position of gathering holes A, B and C; two small pots (1 and 2); three large pots (3–5); and gathering iron.

The pot furnace had an internal shelf that held a number of ceramic pots (also known as crucibles) full of glass. The shelf (W. about 0.3 m when fired) inclined slightly downward toward the center of the furnace. The furnace had three gathering holes: (A) to the left of the stokehole, (B) to the right of the stokehole, and (C) at the rear of the furnace (Fig. 1). There was also a small hole in the top of the furnace. Two small pots (1 and 2) were placed in front of gathering hole A, two large pots (4 and 5) were placed in front of gathering hole B, and one large pot (3)was placed in front of gathering hole C. Pot 3 failed, and so gathering hole C was usually left closed, while gathering holes A and B were generally left open.

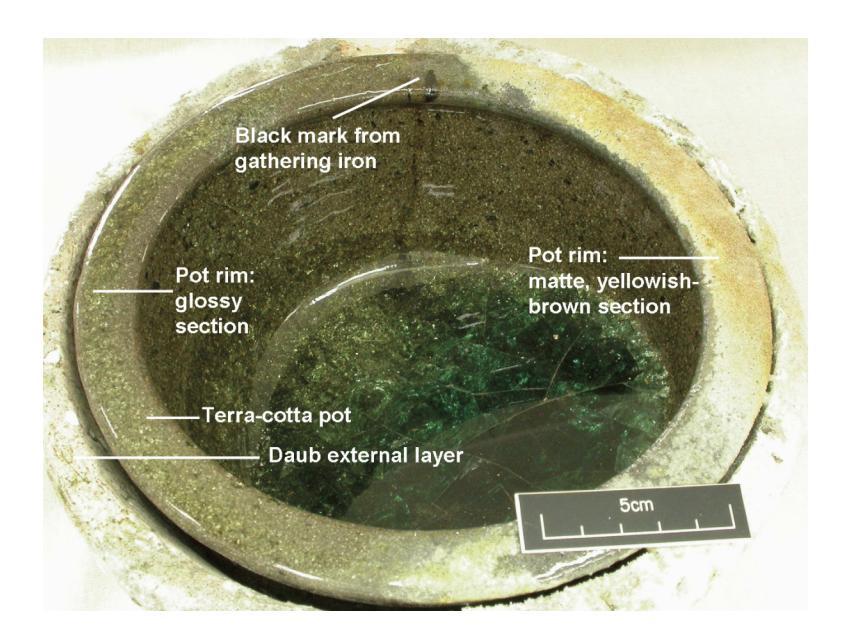
FIG. 2. Small pot after use, showing glossy glaze on left side of rim, matte opaque yellowish brown glaze on right side of rim, and black mark left by gathering iron.

Ceramic pots were used to hold the glass in the pot furnace. Each was a terra-cotta vessel with a thick gray external daub layer. During the firing, the daub layers partly pulled away from the pots, leaving a gap between the two (Fig. 2).

Walls. Although the pots were originally unglazed, a glaze developed on the outer walls and rims during use. The glaze on the external daub layer was semiopaque pale green and finely crazed. In contrast, thick vertical streaks of transparent colorless glaze were noted down the outer face of the daub layer on the side of the pots that had faced into the furnace (Fig. 13). There were also greenish glassy deposits between the outer layer of daub and the terra-cotta vessel within (Fig. 2). Only the bases of the pots re-

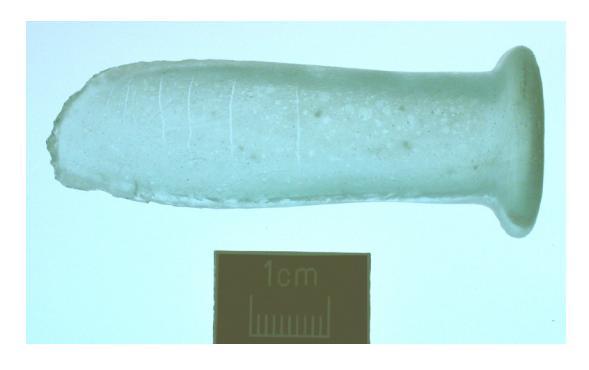
FIG. 3. Broken neck of vessel, where external surface became dull while glass was annealed in lehr (photographed on light box).

The glass vessels produced in the experiments were annealed in the lehr, but many of them developed dull surfaces (Fig. 3). These were examined to determine why this change had occurred.

Dulling of the Glass. The external surfaces of some of the glass vessels annealed in the lehr became dull. Figure 3 shows the neck of a glass vessel that was accidentally overheated in the lehr, causing it to droop. Where the glass has stretched, the thin surface layer of dulled glass has broken in places, and so bands of dulled glass alternate with fresh glass. XRF analysis of the dulled surface of the vessel neck detected increased levels of sulfur and zinc relative to fresh glass from the fractured edge of the same vessel, which contained little sulfur and no detectable zinc. SEM images of the glass (Fig. 9) show that the dulled glass had a pockmarked appearance. These depressions (D. about 1-3 µm) scatter light at the surface of the glass, causing it to appear dull. Increased concentrations of sulfur and zinc were also detected in deposits from inside the furnaces and lehr, and in the glaze covering the inside of the furnaces (see below). These elements originated from the fuel, but they became volatile in the heat of the firing chamber. Therefore, the waste gases from the fuel, in particular the sulfur compounds they contain, play an important role in the dulling process.

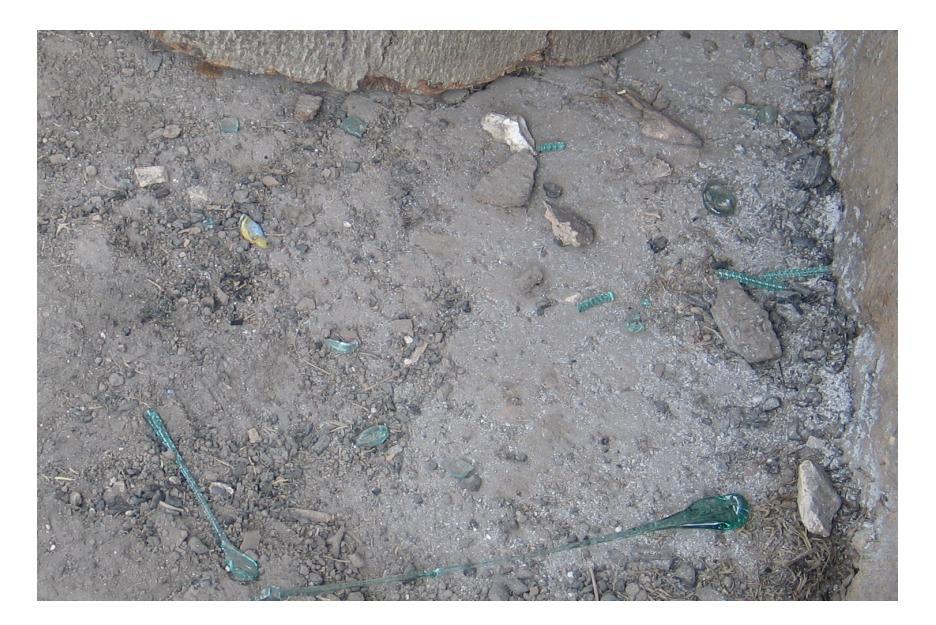
FIG. 4. Fragments of glassworking waste around pot furnace.

During the glassworking, trails, drips, moils, and broken fragments of glass were deposited around the pot furnace (Fig. 4). Large lumps (Fig. 5) and small blobs (Fig. 6) of glassy waste were also recovered from inside the pot and tank furnaces after the experiment had been completed. These different types of waste are described and characterized.

Glassworking Waste Deposited outside the Furnaces. Much of the waste glass generated during each glassworking session was broken up by plunging it into a bucket of cold water, and it was then reused. However, some waste from gathering, blowing, and working the glass fell on the floor around the pot furnace (Fig. 4). This included drips and trails, broken fragments of vessel and window glass, and moils (small collars of glass from around the blowing iron). The composition of most of this glass waste was not significantly different from that of the original glass. Some of the moils, however, had small flakes of black iron oxide scale from the blowing iron adhering to their inner surface, and these flakes had started to react with the glass.

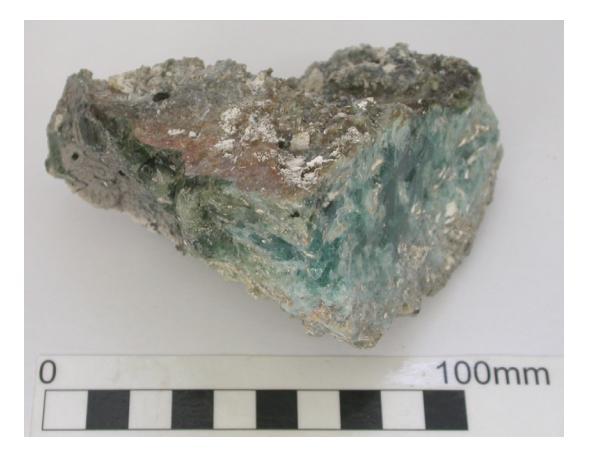
FIG. 5. Large lump of glass waste recovered from within pot furnace.

mainly opaque and the surfaces were discolored (Fig. 5). Some ash still adhered around the edges, and the glass had yellowish white or opaque brown outer surfaces and patches of opacity within. A significant amount of ash had been incorporated in the glass, reacting to produce the observed changes in composition and microstructure. These lumps were often greatly enriched in lime, magnesia, and phosphorus (Table 3). A sodium-calcium-phosphate-silicate phase was occasionally present at the surface, similar to that seen on the yellowish section of the pot rims (see below). Disodium-dicalcium-trisilicate, melilite, and wollastonite were common, especially near the surfaces. Samples with particularly high concentrations of lime contained the disodium-dicalcium-trisilicate phase throughout (Fig. 10).

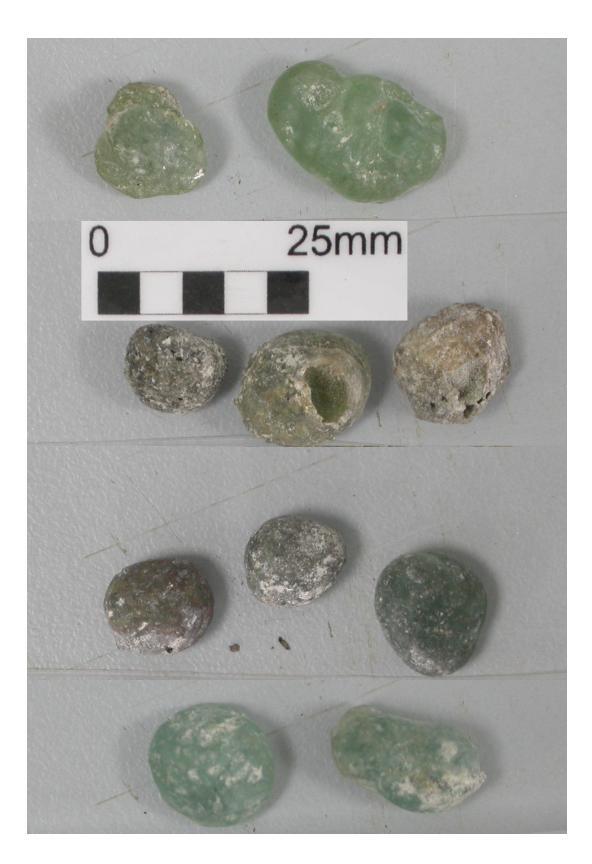
FIG. 6. Small blobs of glass waste recovered from ashpit of pot furnace. From top: yellowish green, with rough surface, brown, and blue-green.

Glass Waste within the Furnaces. Glassy waste was also recovered from inside the furnaces after the first firing. The tank furnace failed, so a large spill of glass was found in the firing chamber. One of the pots in the pot furnace also failed, causing the contents to flow into the firing chamber. In addition to these large spills, small glass blobs were recovered from the ash when the firing chamber of the pot furnace was emptied. Some of these were brownish, some had rough surfaces, and others were blue-green, similar to the original glass (Fig. 6).

The small blobs of brown glass (Fig. 6) were higher in alumina, potash, iron oxide, and titania relative to the original glass composition (Table 3). They contained crystals of wollastonite, meli-

The compositions of the brown and roughsurfaced blobs (Fig. 6 and Table 3) indicate that they were formed from the glassy material that dripped from the furnace walls or shelf, or from the exterior of the pots. This glassy material was a mixture of soda-lime glass and aluminaand potash-rich glaze from the pots and the furnace walls. The higher concentrations of iron resulted in a brownish color, and the rough surfaces may be related to the high concentrations of alumina, resulting in greater viscosity. In the firing chamber, the droplets of glass also started to react with the lime-rich fuel ashes, resulting in the precipitation of the lime-rich crystalline phases noted previously.

The small blue-green glass blobs (Fig. 6) recovered from the ashpit of the pot furnace had compositions similar to that of the original glass (Table 3). Some reaction with lime-rich ash had occurred in the firing chamber, however, resulting in very fine sodium-calcium-silicate crystals toward the surface. These blobs of glass were formed from the glass that spattered out of the pots when they were refilled with cullet. Although drips of glass were also lost during the gathering, these tended to fall between the pot and the gathering hole, rather than over the firing chamber, because the gathering iron was not extended that far.

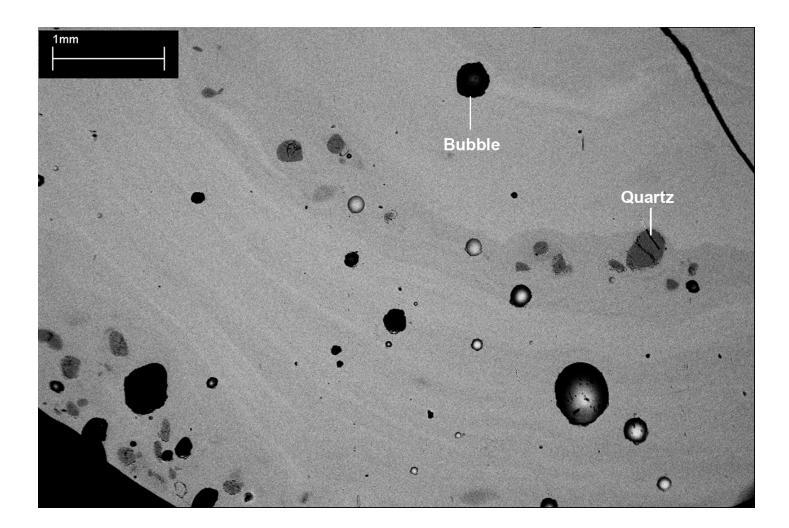
FIG. 7. Backscattered SEM image of heterogeneous gather of glass after heating batch for 14 hours in pot furnace.

bubbles. Analyses also found that the gather at 14 hours had quite a variable composition. Glass that had been heated for more than 50 hours contained occasional bubbles but few inclusions, and it was compositionally more homogeneous.

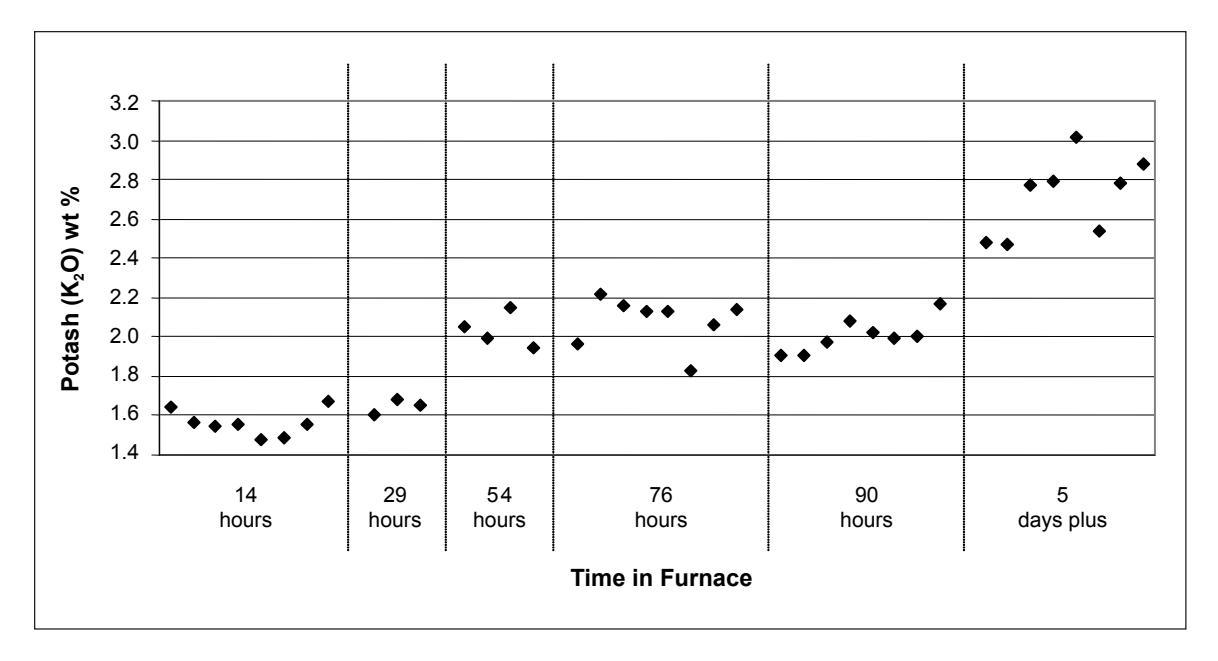
FIG. 8. Plot showing EDS results for concentrations of potash in gathers of glass taken at intervals from otherwise undisturbed (but leaking) pot.

However, the compositions of the gathers also differ slightly from one another, suggesting that the composition of the glass in the pot changed over time. Initially, three random areas (each about 2.5 mm²) of the glass samples were analyzed, including undissolved particles when these were present, but additional analyses of several samples were made at a later date. Figure 8 shows the results for potash. Although there is scatter in

the data points because of factors such as the heterogeneity of the samples, the small areas analyzed, and the reproducibility of the technique, the concentrations of potash appear to have increased over time. Concurrently, the concentrations of silica decreased between the first and final samples (by roughly 2 wt % overall), noticeably diluted by the increased levels of alkali. (Changes in the concentrations of other elements were too small, relative to the scatter, to suggest any trend.)

This observation suggests that the alkali-rich waste gases in wood-fired glassworking furnaces can affect the composition of the glass when it is heated over prolonged periods. This results in increased concentrations of alkali, potash in particular. Some instances in which similar observations have been made with archeological material are discussed later in this article. In gas-fired furnaces, by contrast, reduced concentrations of alkalis caused by volatilization, especially for soda, are often noted.

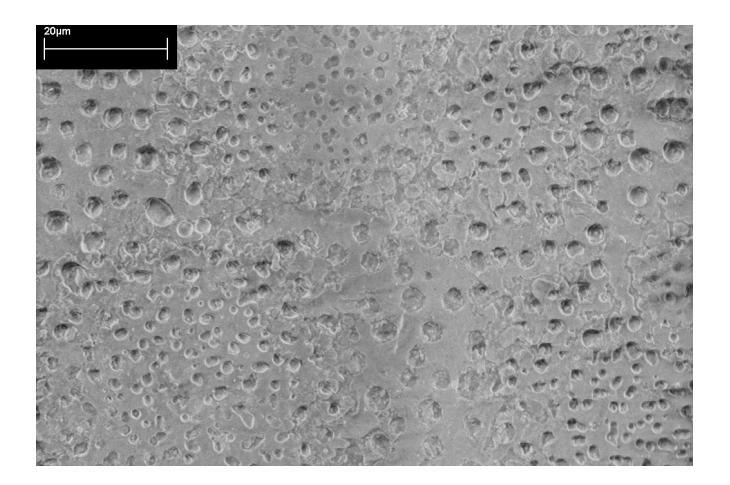
FIG. 9. SEM image of dull surface of glass vessel in Figure 3, showing small depressions covering surface.

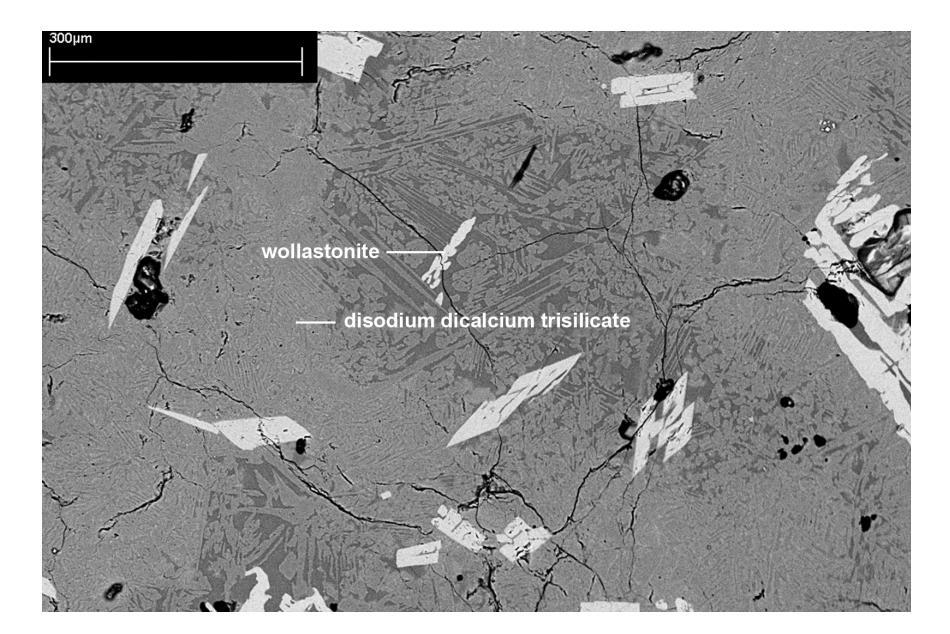
FIG. 10. Backscattered SEM image of large lump of glass waste from ashpit of pot furnace, which has become highly crystalline.

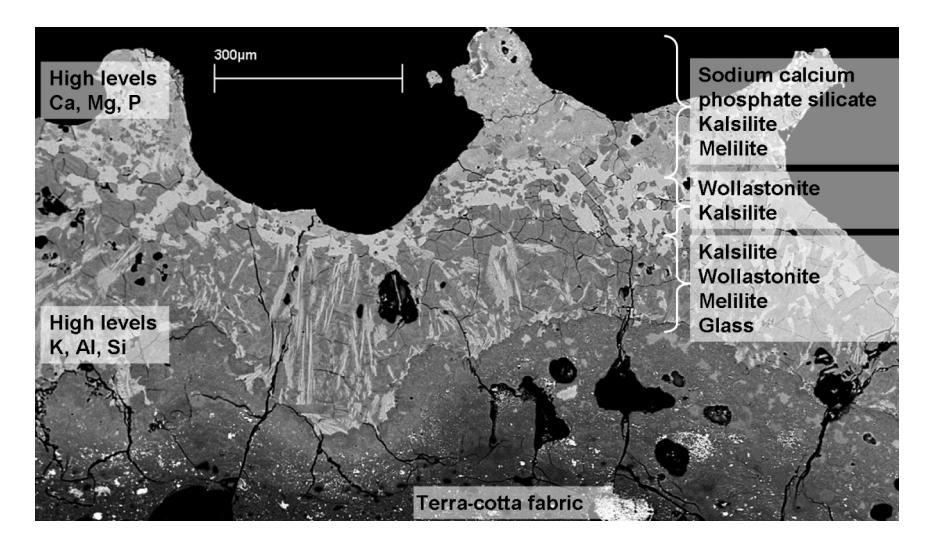
FIG. 11. Backscattered SEM image of section from rim of terra-cotta pot, showing highly crystalline microstructure of opaque yellowish brown glaze on surface.

A backscattered SEM image of the complex microstructure of the yellowish brown glaze on the terra-cotta pot is shown in Figure 11. At the surface were small amounts of an alkalicalcium-phosphate-silicate phase, in addition to kalsilite and melilite. Beneath these were regions rich in wollastonite and, moving lower, increasing amounts of kalsilite in a glassy matrix. The upper layers of the microstructure on the daub also contained numerous phases, including wollastonite and melilite surrounded by soda-rich glass. The lower layers consisted of large, elongated wollastonite crystals, as well as melilite in a glass matrix.

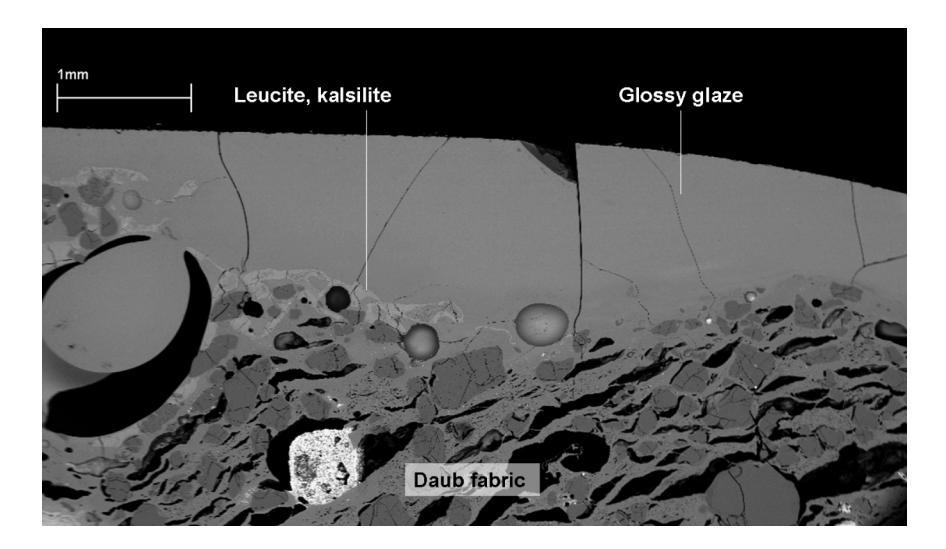
FIG. 12. Backscattered SEM image of section from rim of daub layer from around pot, showing homogeneous glossy glaze on surface.

The glaze on the outer surface of the daub layers was glassy and homogeneous. However, a layer of crystalline phases, consisting of leucite and kalsilite, had formed at the interface between the glaze and the daub, because of the high concentrations of alumina and potash in those regions (Fig. 12). These small crystals scattered light, and so made the glaze appear semiopaque. This glaze had formed mainly from the reaction of the daub with fluxes in the waste gases from the burning fuel. The glaze was therefore rich in compounds found in the daub, such as alumina, silica, titanium, and iron (the latter imparted the slight green color to the glaze). It also contained high concentrations of potash and soda that had volatilized from the fuel ashes, but it had little lime or magnesia.

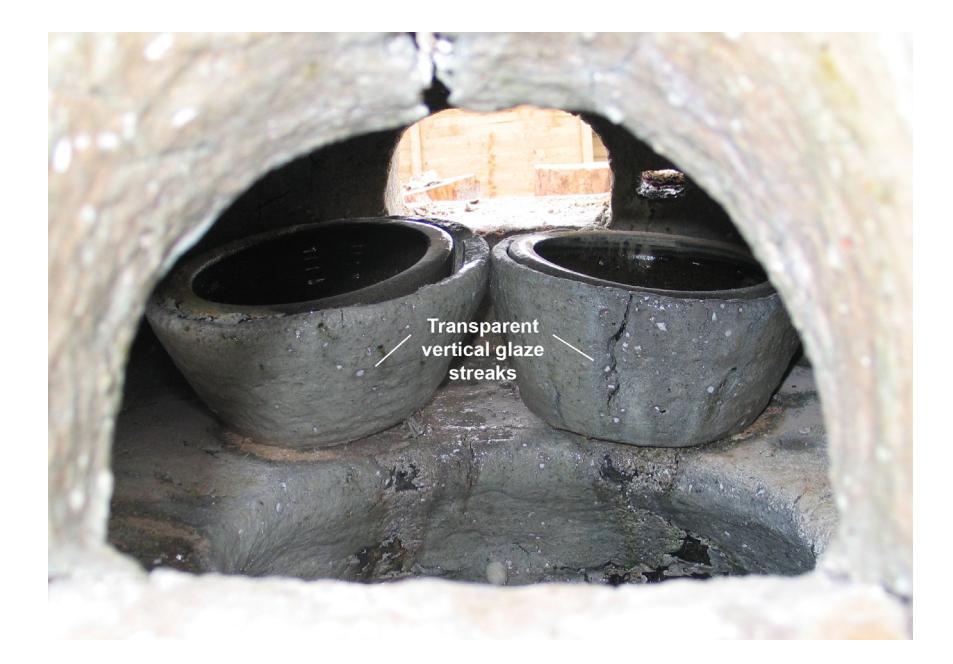
FIG. 13. Large pots (4 and 5) by gathering hole B, viewed through gathering hole A, showing glazed internal surfaces of furnace, glazed external surfaces of pots, and streaks of more transparent glaze running down pot walls and under furnace shelf.

During use, each of the furnaces developed a glaze over the interior surfaces, and some glass was also spattered or spilled on these surfaces, particularly on and beneath the shelf (Fig. 13). However, circular unglazed patches were left on the shelf when the glass pots were removed. The top hole of the pot furnace became visibly corroded during the experiment.
